Roof Recon Report for [Address redacted]

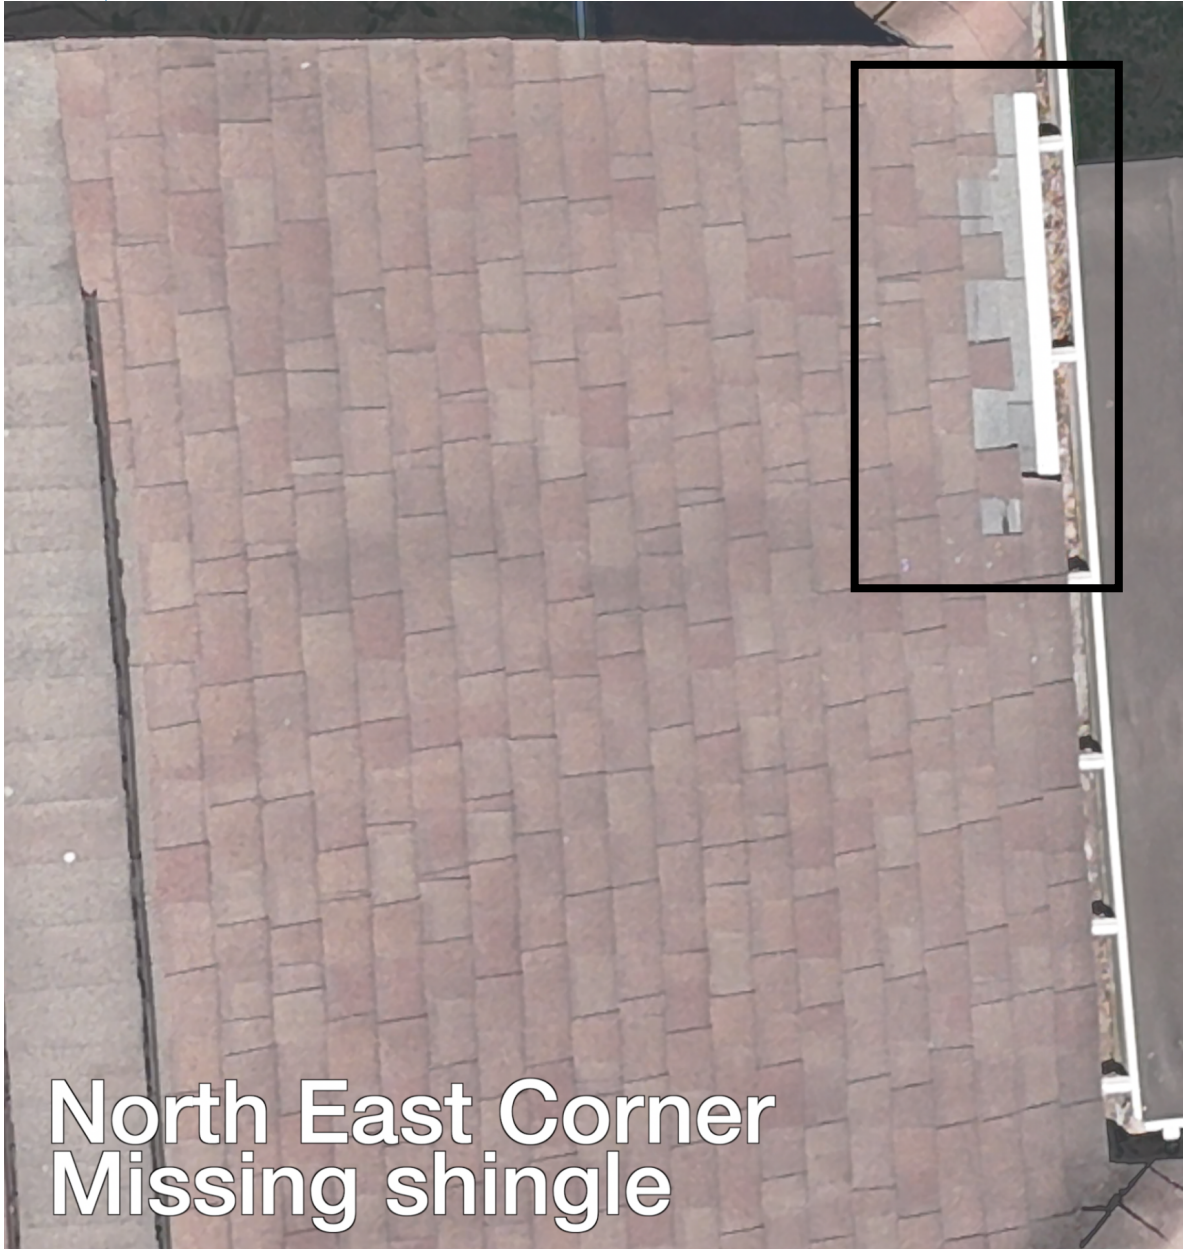
Photo 1

- There is at least one, possibly two missing shingles on the north east corner. Home owner confirmed finding bits of shingle in the garden over the winter. There is still sufficient overlap of the existing shingles that there doesn't appear to be a direct path for water to leak into the roof, but should probably be fixed before next winter. (See photo 1)

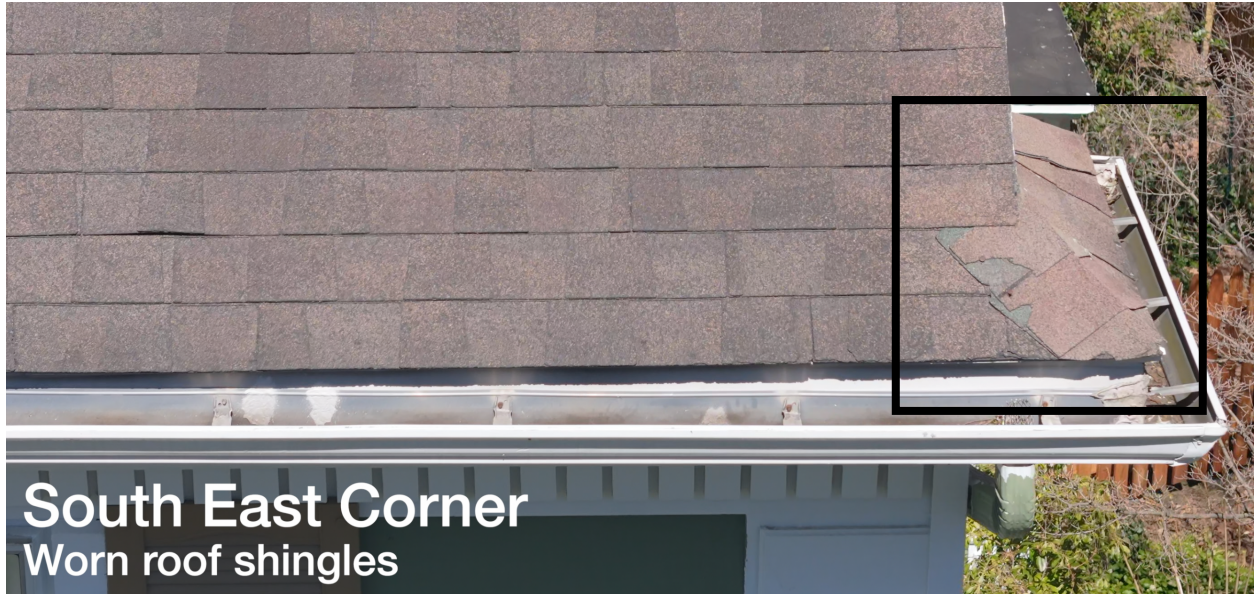
- In the south east corner of the roof, there appears to be a layer of shingle worn off, but this does not appear to be an urgent condition. (See photo 2)

South East Corner
Worn roof shingles
